**Flood Control Project Maintenance
Levee Inspections**

Fall 2010 Levee Maintenance Deficiency Summary Report

Reclamation District No. 0999 Netherlands

Levee Inspection Report By Mile - Fall 2010

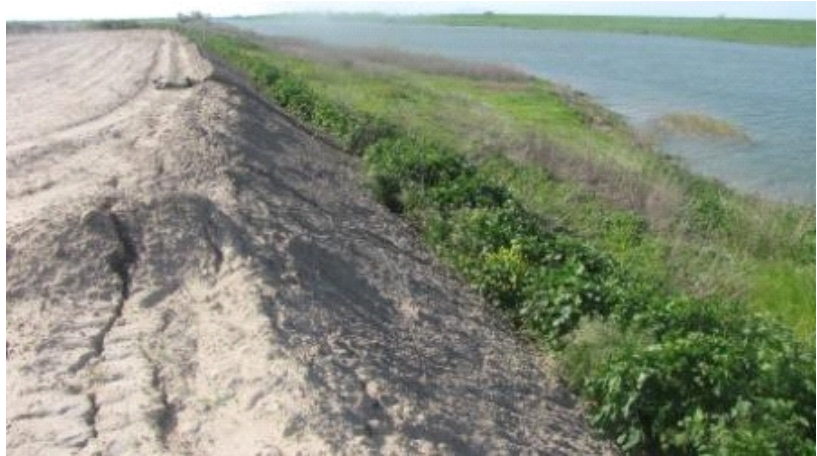
richard_f_20100921_230.jpg

Looking southwest at fill on waterside berm

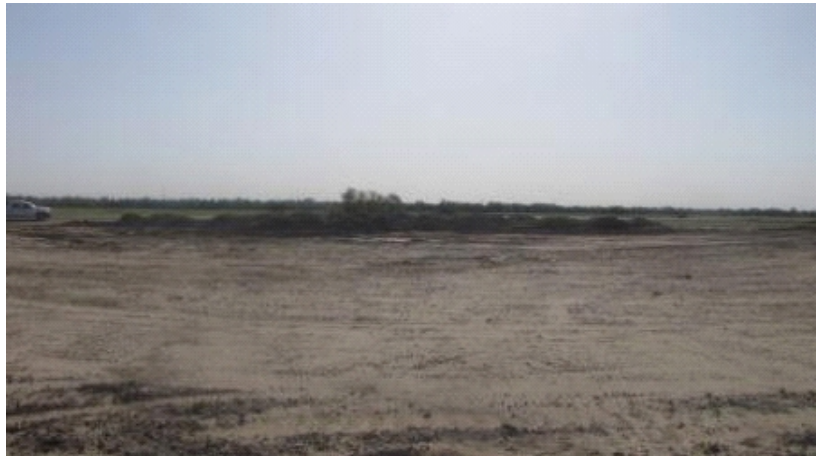
richard_f_20100921_231.jpg

Looking east at fill on waterside

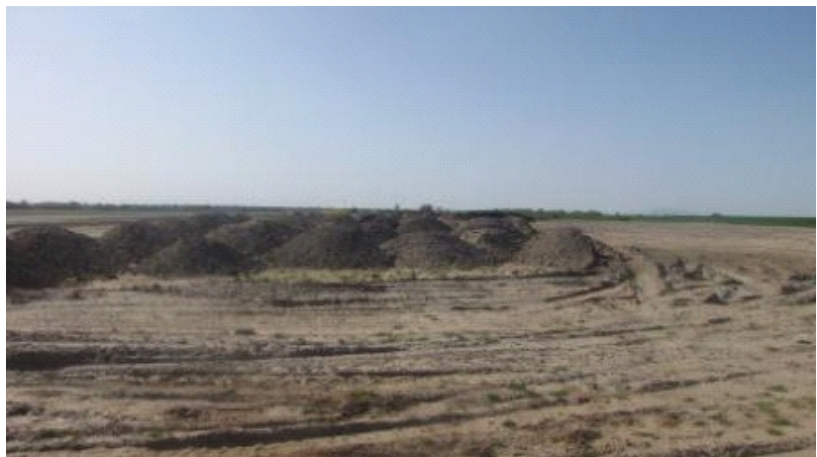
richard_f_20100921_232.jpg

Looking south at fill on waterside shoulder and slope.

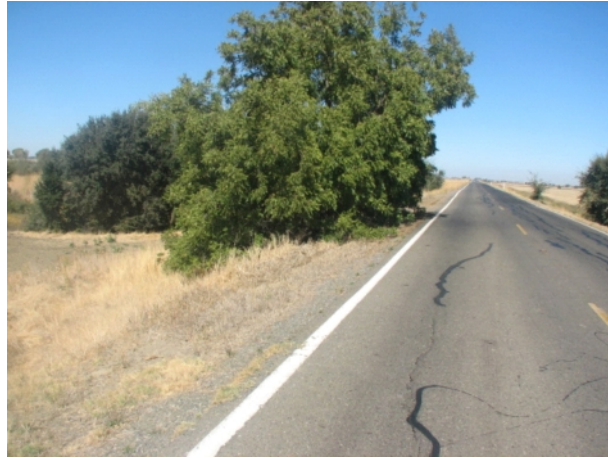
richard_f_20100921_233.jpg

Looking east at overgrown trees on waterside slope and shoulder

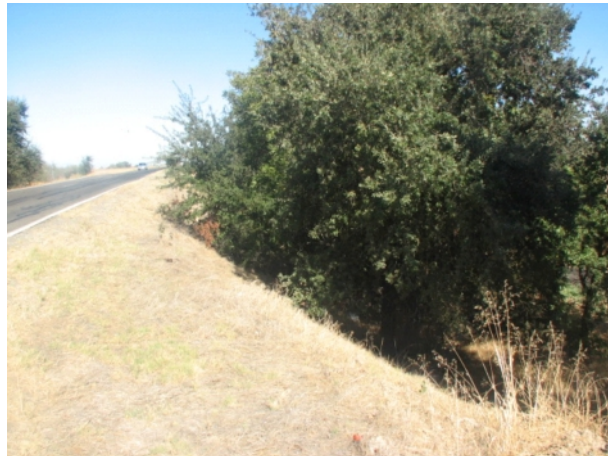
richard_f_20100921_234.jpg

Looking west at overgrown trees on waterside slope and toe.

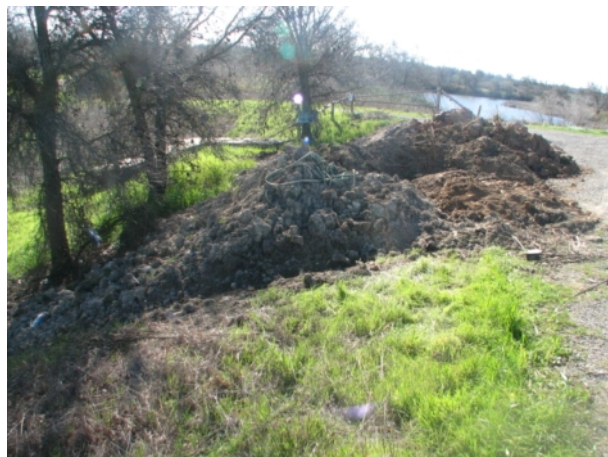
richard_f_20100921_235.jpg

Material pile on landside shoulder at LM 1.78

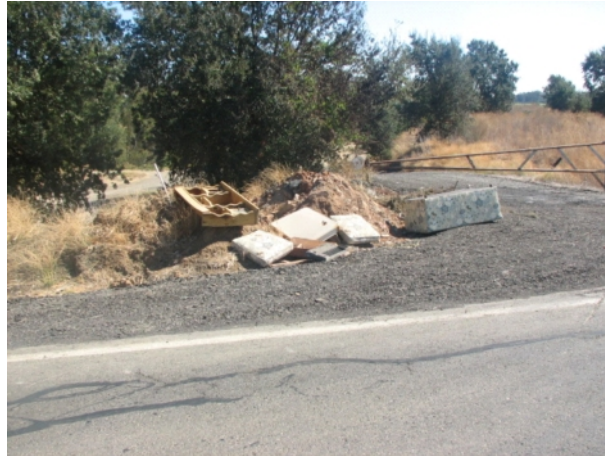
richard_f_20100921_236.jpg

Looking north at garbage pile on landside shoulder.

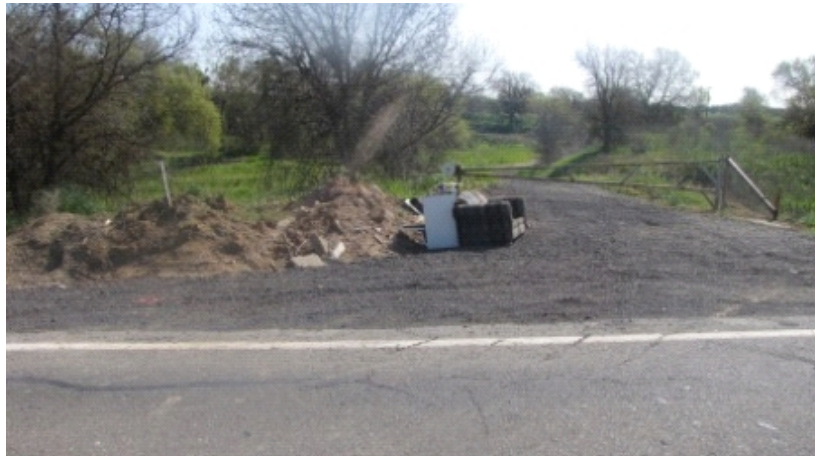
richard_f_20100921_237.jpg

Looking east on garbage on landside shoulder and slope next to ramp.

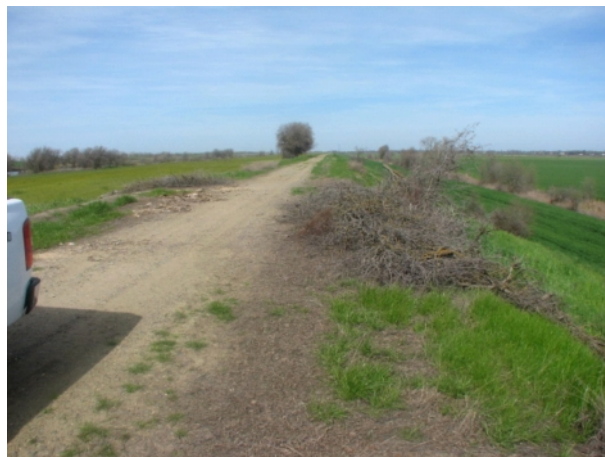
richard_f_20100921_238.jpg

Pruning pile on waterside shoulder.

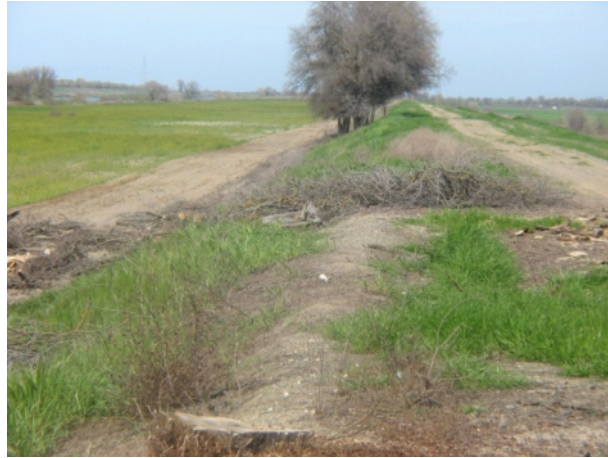
richard_f_20100921_239.jpg

Prunings on waterside shoulder, slope & toe.

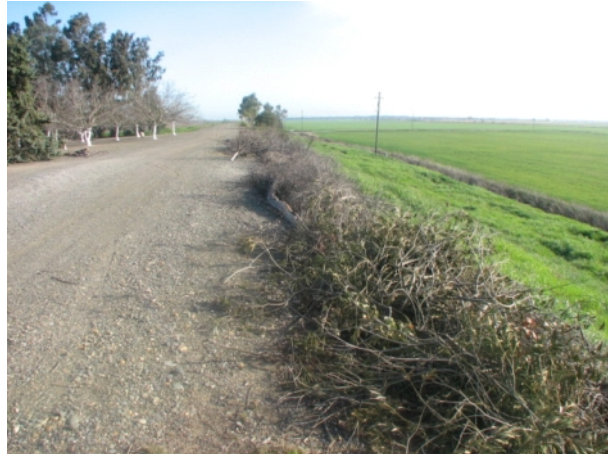
richard_f_20100921_241.jpg

Prunings along landside shoulder.

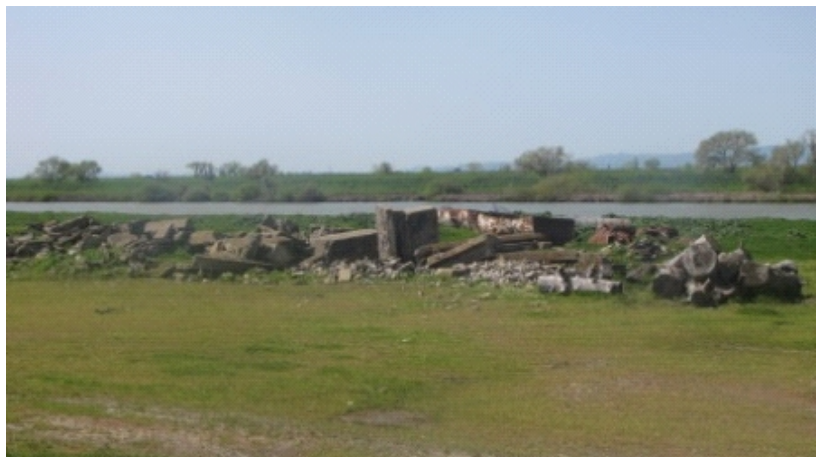
richard_f_20100921_245.jpg

Looking west at concrete rubble on waterside berm.

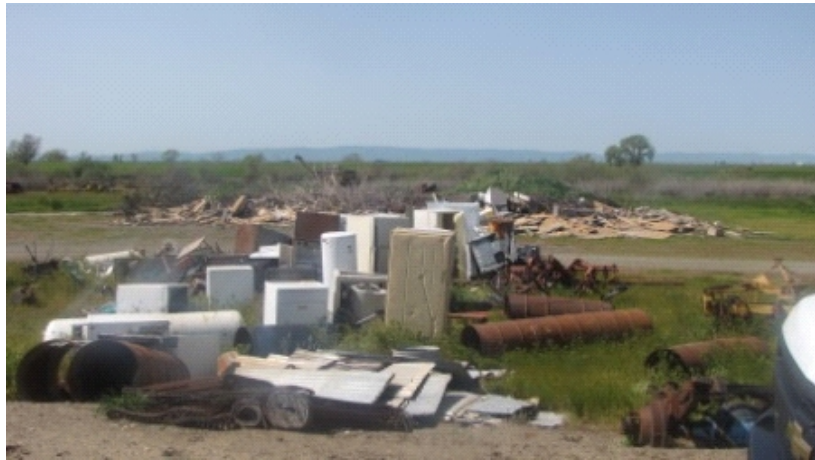
richard_f_20100921_246.jpg

Looking southwest at garbage on waterside toe and berm.

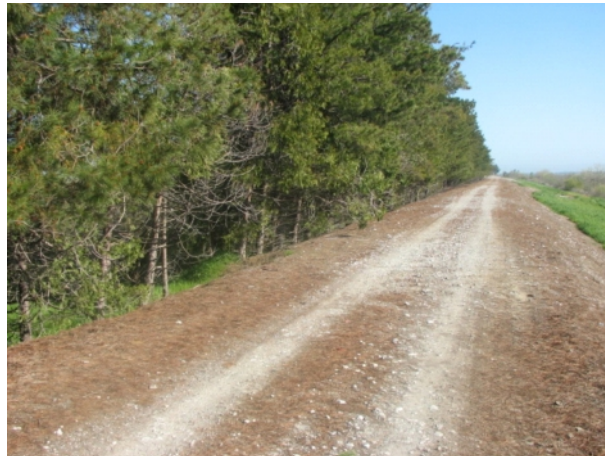
richard_f_20100921_243.jpg

Pine trees along waterside shoulder & slope. (Site of a old christmas tree farm).

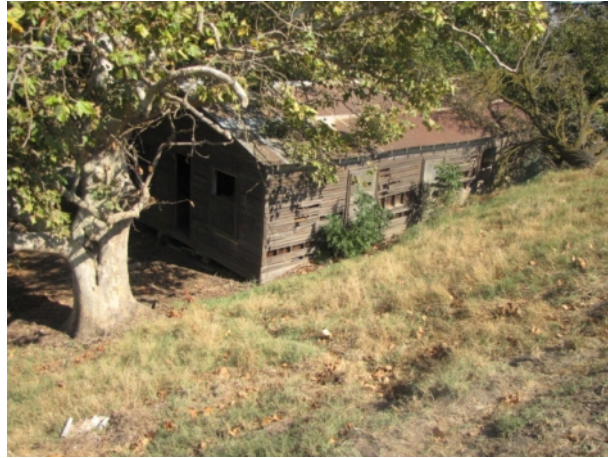
richard_f_20101021_333.jpg

Looking northwest at building at landside toe.

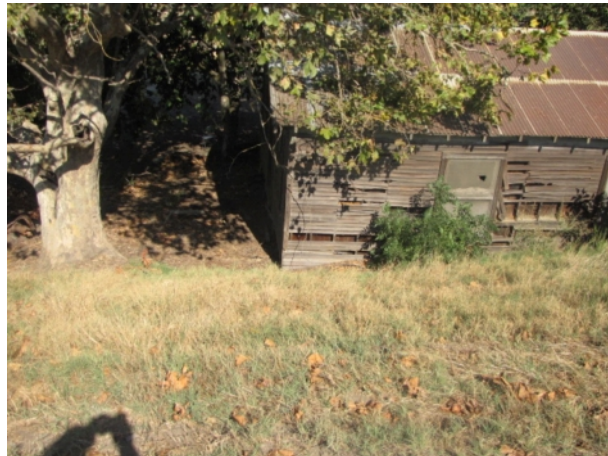
richard_f_20101021_334.jpg

Looking west at building at landside toe.

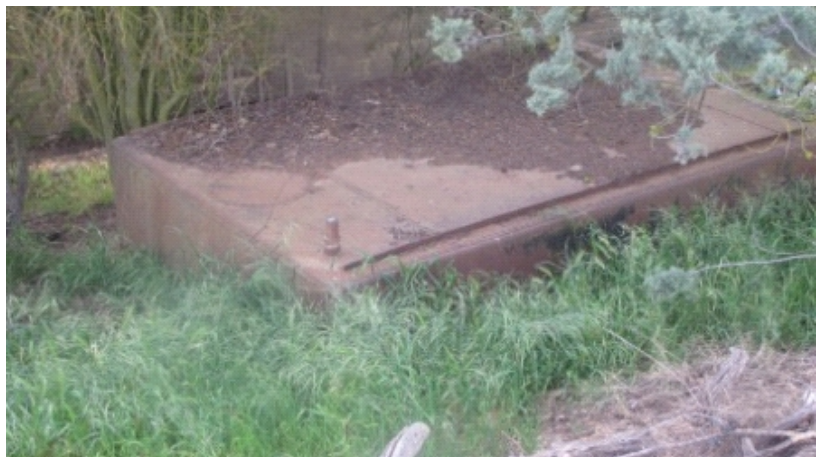
richard_f_20100921_254.jpg

Looking north at tank on landside slope and toe.

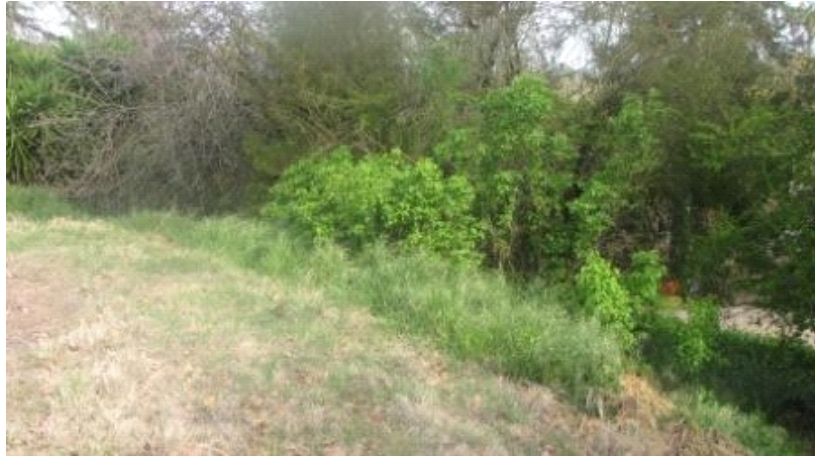
richard_f_20100921_255.jpg

Looking southwest at dense veg. on landside toe.

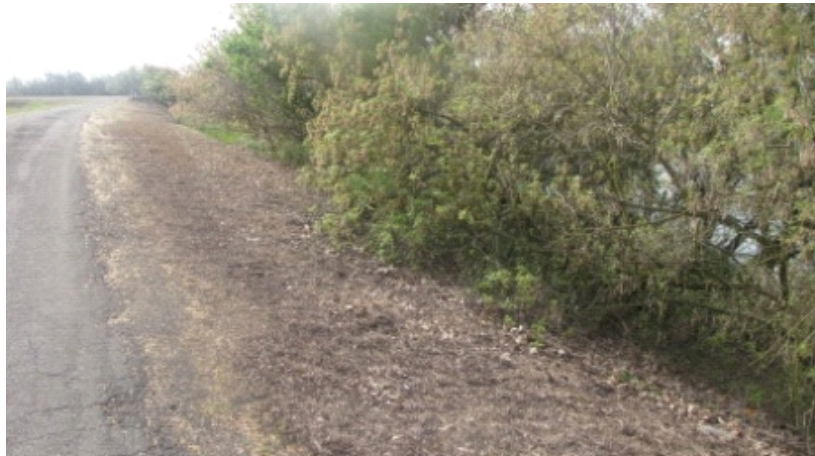
richard_f_20100921_252.jpg

Looking northeast at dense veg. on waterside slope.

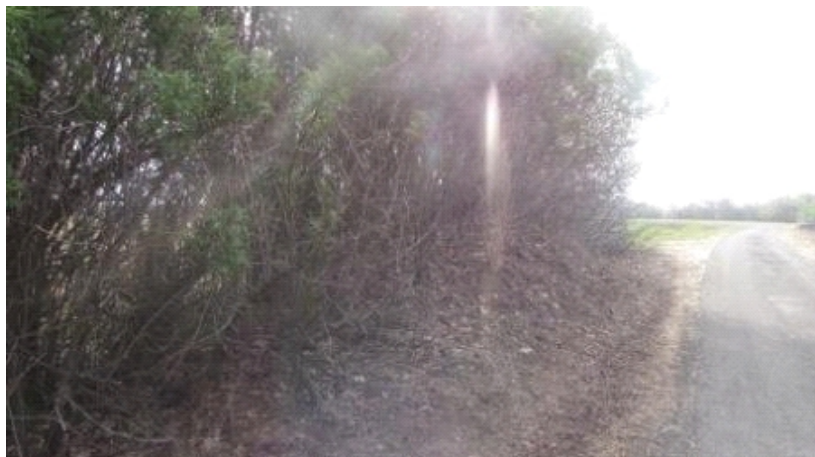
richard_f_20100921_253.jpg

Looking southwest at elderberry bush on landside shoulder and slope.

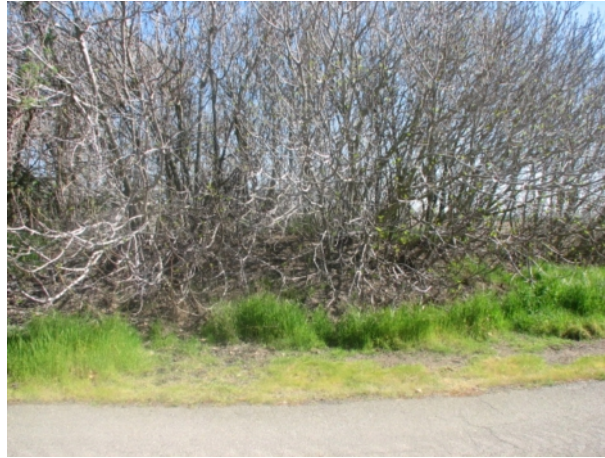
richard_f_20100921_257.jpg

Front view of overgrown fig tree on landside shoulder.

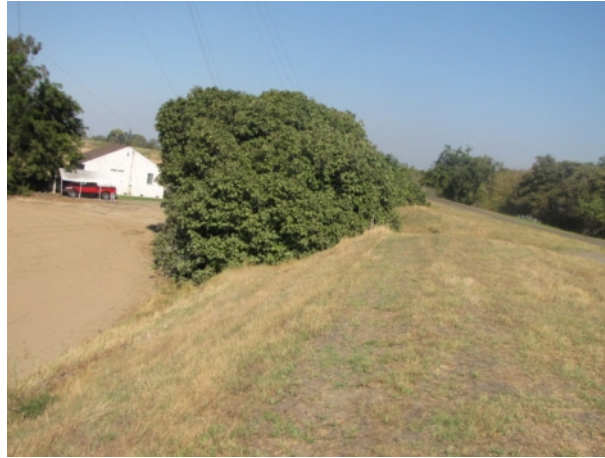
richard_f_20101021_335.jpg

Looking north at dense trees on landside slope and toe.

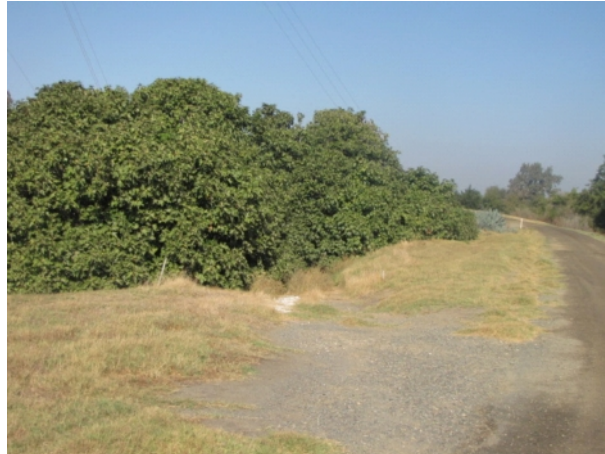
richard_f_20101021_336.jpg

Looking northwest at dense trees on landside slope and toe.

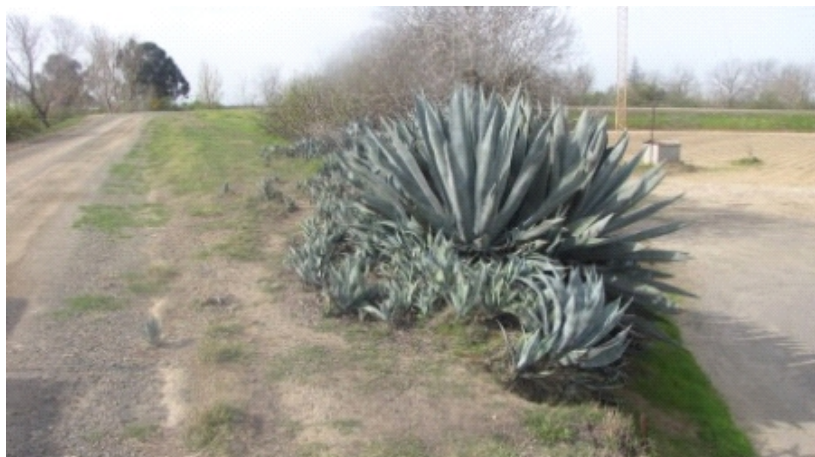
richard_f_20100921_261.jpg

Looking east at cactus and landscaping on landside slope.

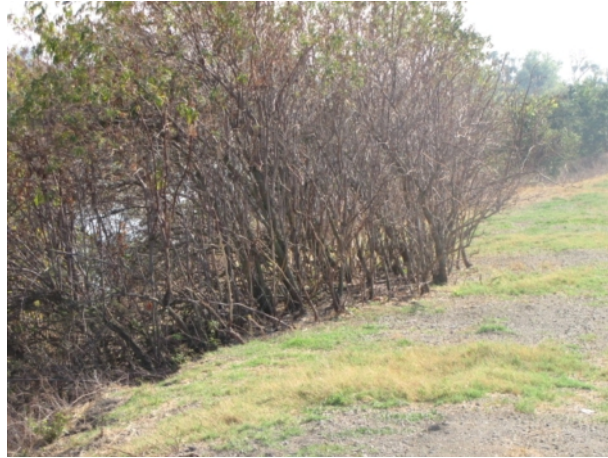
richard_f_20101021_337.jpg

Looking south at thinned Elderberry on waterside slope.

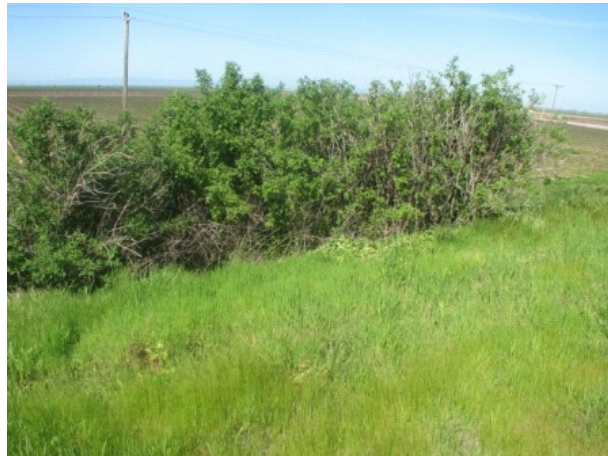
richard_f_20100921_264.jpg

Elderberries blocking view of landside toe.

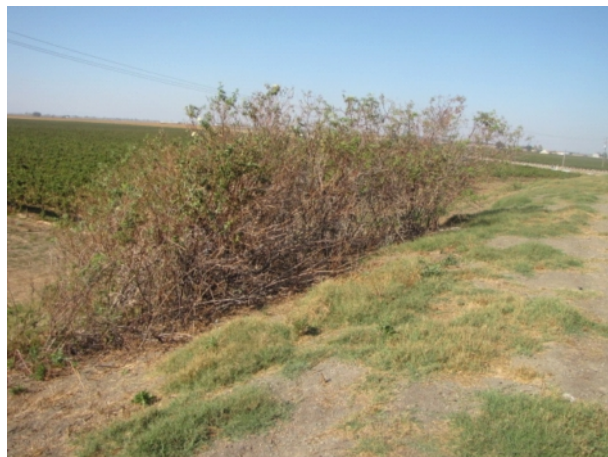
richard_f_20101021_338.jpg

Looking north at thinned elderberry on landside slope.

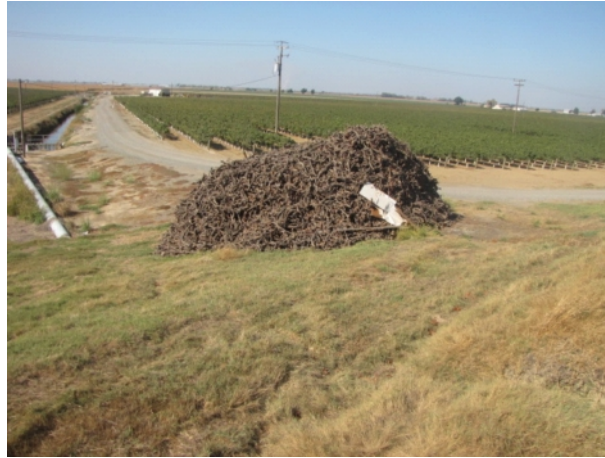
richard_f_20101021_339.jpg

Looking northwest at pruning pile on landside toe.

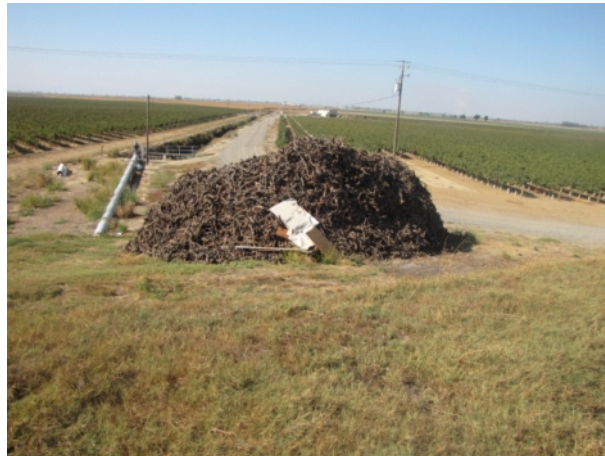
richard_f_20101021_340.jpg

Looking west at pruning pile on landside toe.

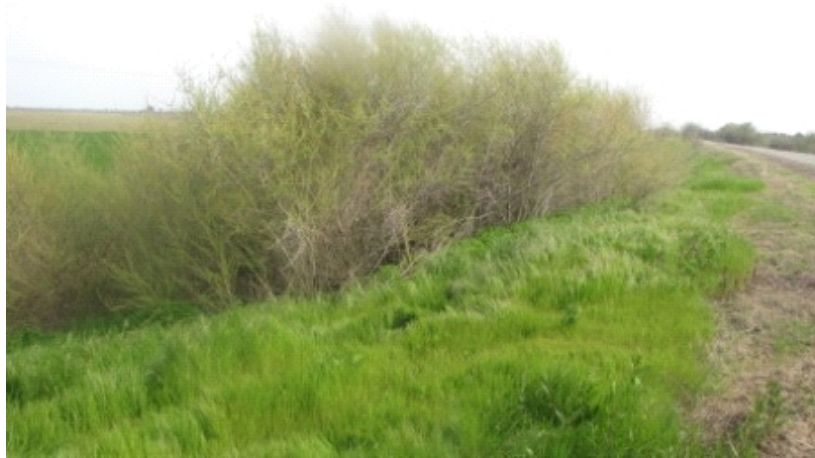
richard_f_20100921_267.jpg

Looking north at willow on landsie slope and toe.

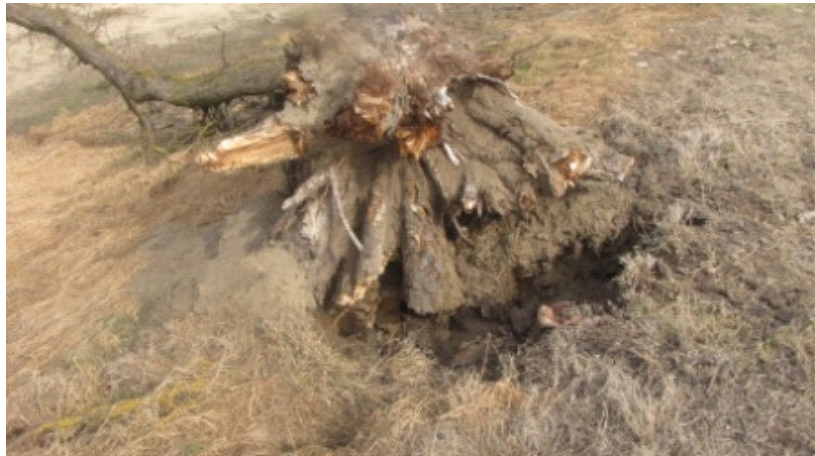
richard_f_20100921_269.jpg

Looking east at dead tree stump and hole on landside shoulder and slope.

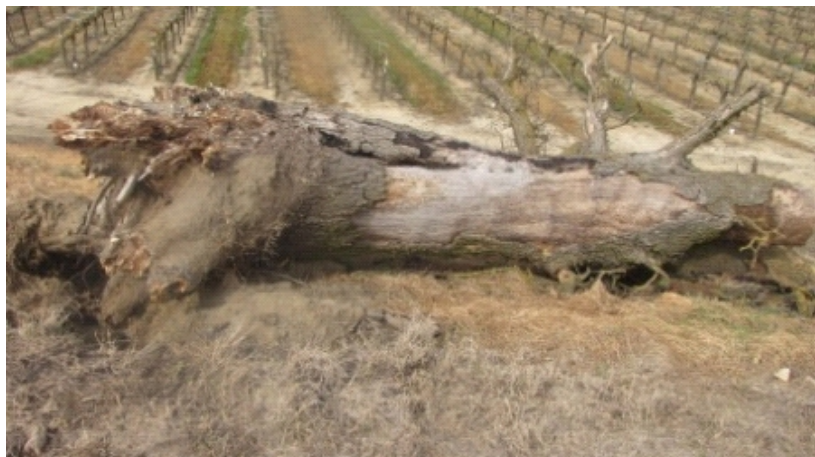
richard_f_20100921_270.jpg

Looking west at dead tree on landside slope.

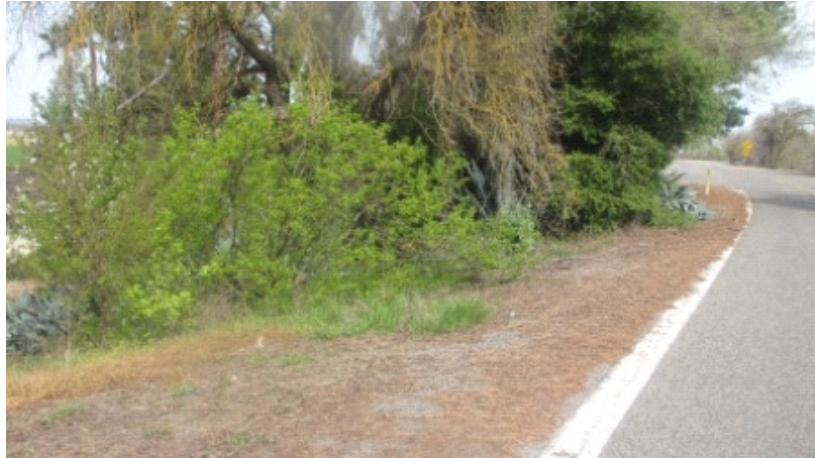
richard_f_20100921_265.jpg

Looking northwest at landscaping and dense veg. on landside slope and toe.

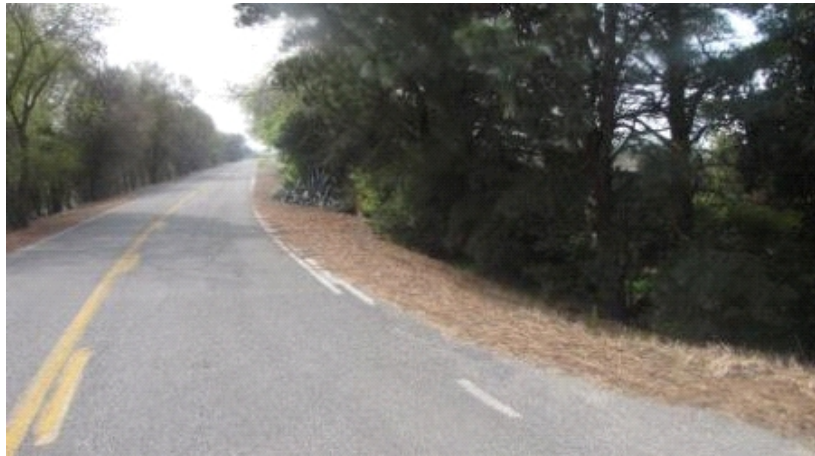
richard_f_20100921_266.jpg

Looking south at landscaping and dense veg. on landside slope and toe.

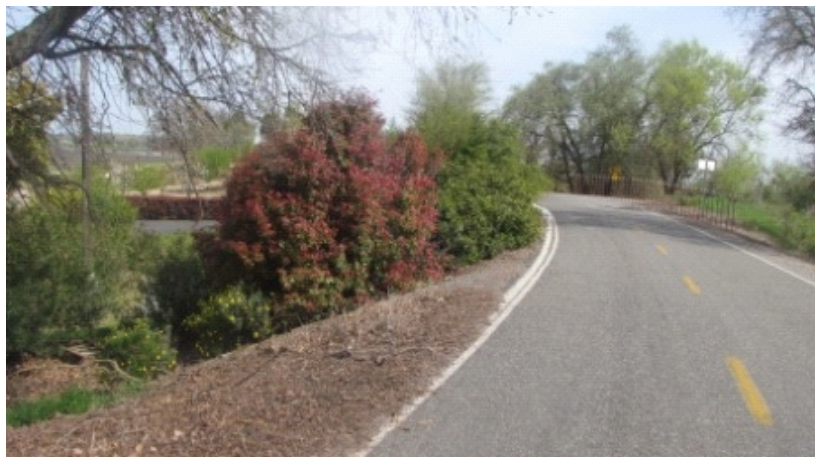
richard_f_20100921_268.jpg

Looking northwest at landscaping on landside slope and toe.

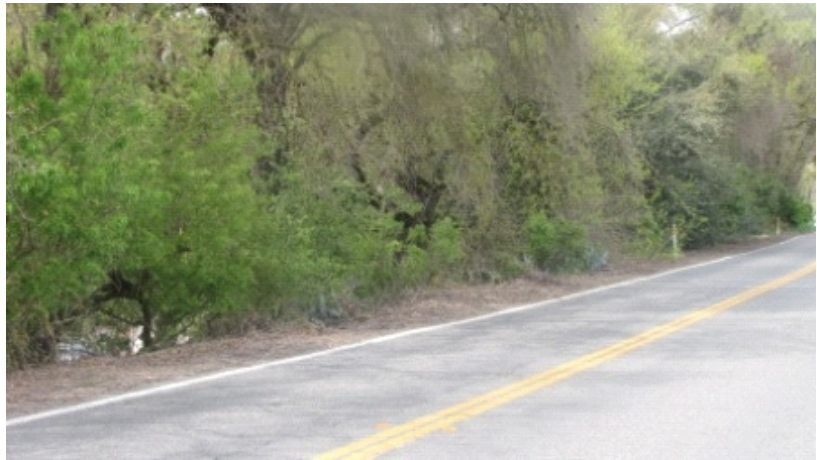
richard_f_20100921_273.jpg

Looking west at dense trees on waterside slope.

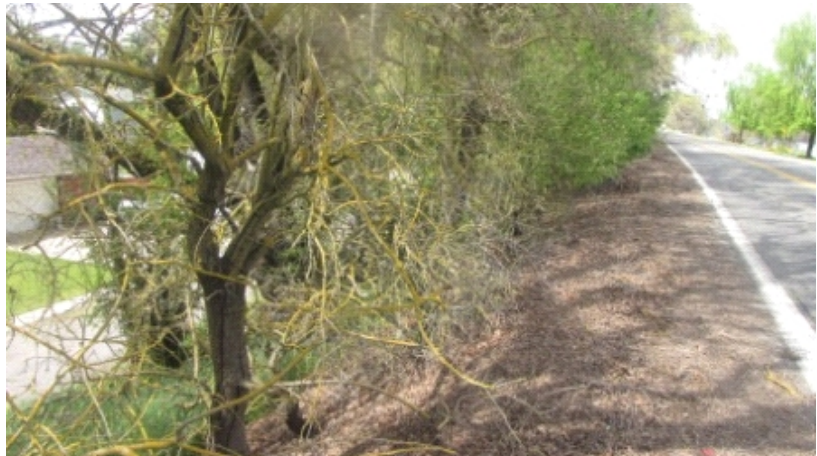
richard_f_20100921_274.jpg

Looking northwest at dense trees on landside slope and toe.

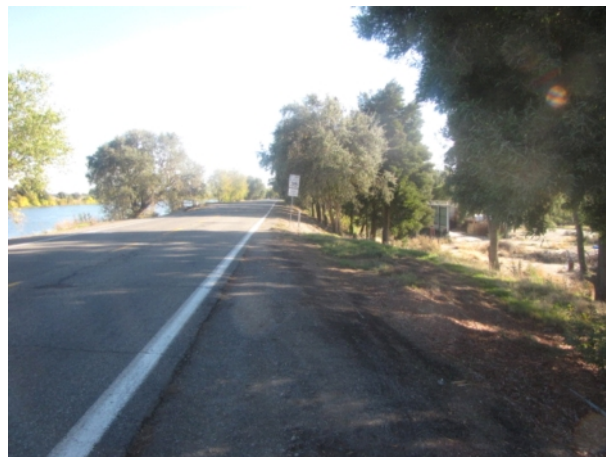
richard_f_20101110_385.jpg

Looking south at trimmed trees on landside slope and removed fence.

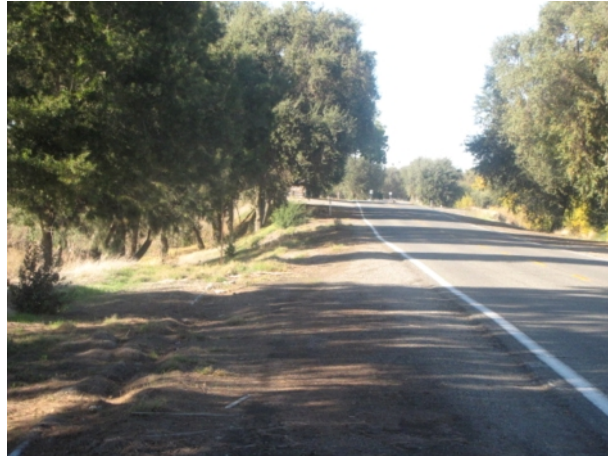
Levee Mile Report Line	11
Start Levee Mile	0.71
End Levee Mile	0.87
Location	Land Side
Category	Earthen Levee
Item	Trim / Thin Trees
Looking north at trimmed trees and removed fence on landside slope.	
richard_f_20101110_386.jpg

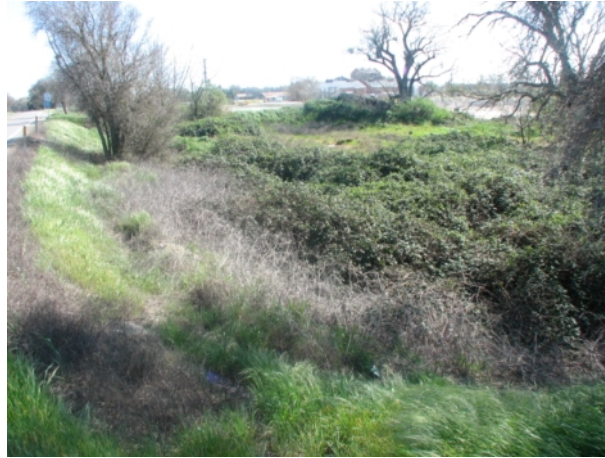
richard_f_20100921_277.jpg

Dense wild roses at landside toe (side view)

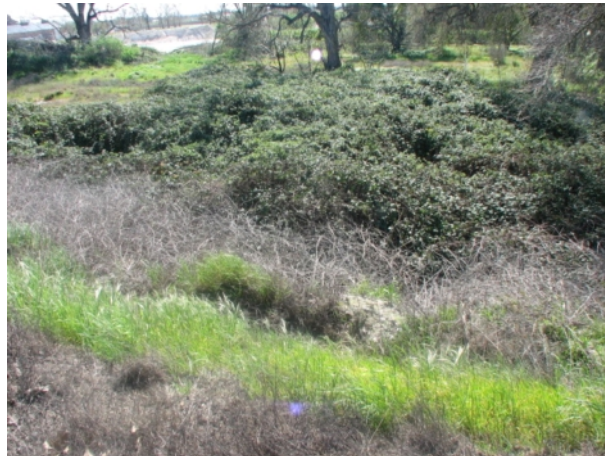
richard_f_20100921_278.jpg

Front view of dense wild roses at landside toe.

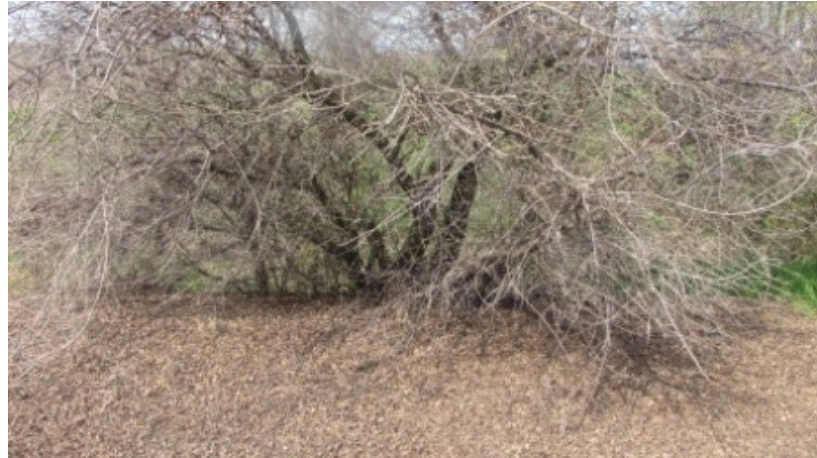
richard_f_20100921_287.jpg

Looking east at overgrown tree on landside slope and toe.

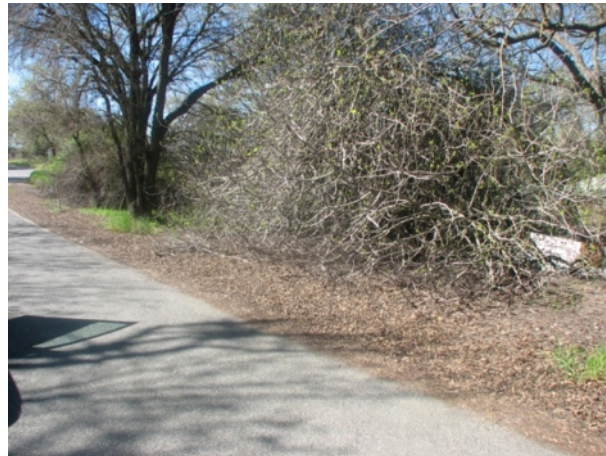
Levee Mile Report Line	15
Start Levee Mile	0.72
End Levee Mile	0.74
Location	Land Side
Category	Earthen Levee
Item	Trim / Thin Trees

Front view of dense trees at landside shoulder.

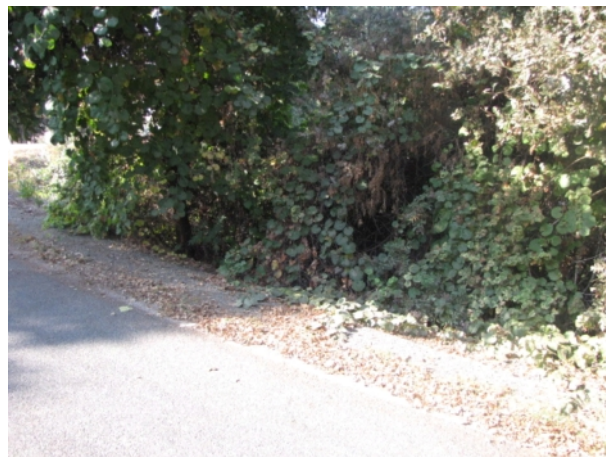
Levee Mile Report Line	15
Start Levee Mile	0.72
End Levee Mile	0.74
Location	Land Side
Category	Earthen Levee
Item	Trim / Thin Trees

Looking west at dense trees on landside slope and toe.

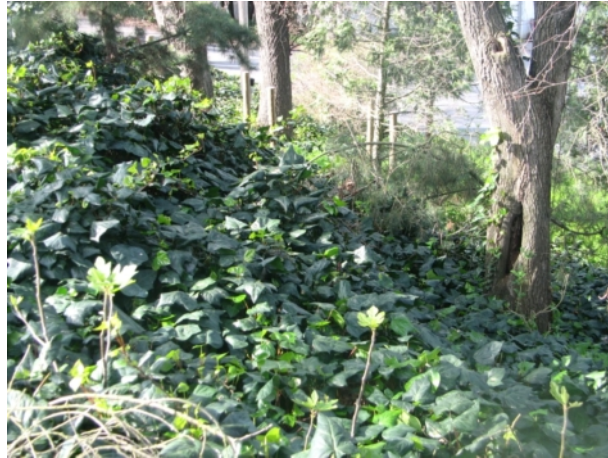
Levee Mile Report Line	17
Start Levee Mile	0.84
End Levee Mile	0.94
Location	Land Side
Category	Earthen Levee
Item	Encroachments
View of landscaping (Ivy) blocking view of landside slope from LM 0.84 to 0.94	
richard_f_20100921_281.jpg

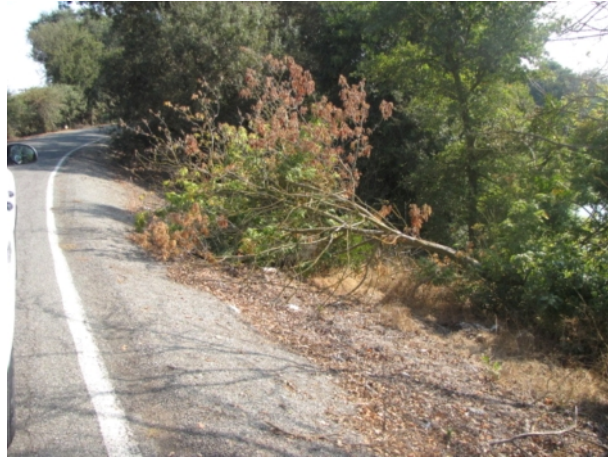
richard_f_20101021_343.jpg

Looking north at down tree on waterside slope.

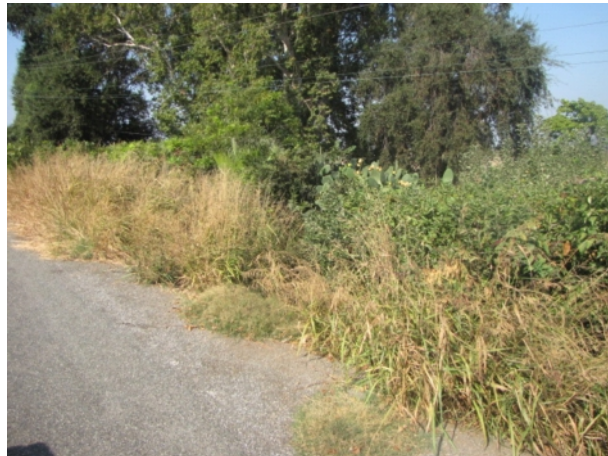
Levee Mile Report Line	24
Start Levee Mile	1.34
End Levee Mile	1.40
Location	Land Side
Category	Earthen Levee
Item	Encroachments

Looking southwest at overgrown landscaping on landside slope.

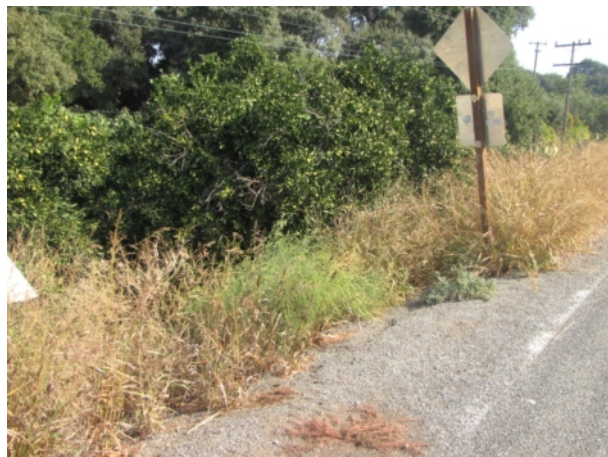
Levee Mile Report Line	24
Start Levee Mile	1.34
End Levee Mile	1.40
Location	Land Side
Category	Earthen Levee
Item	Encroachments

Looking northwest at overgrown landscaping on landside slope.

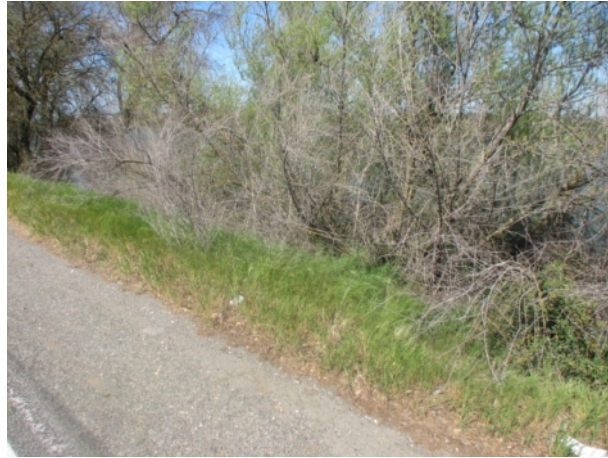
richard_f_20100921_283.jpg

Front view of dense trees along waterside slope.

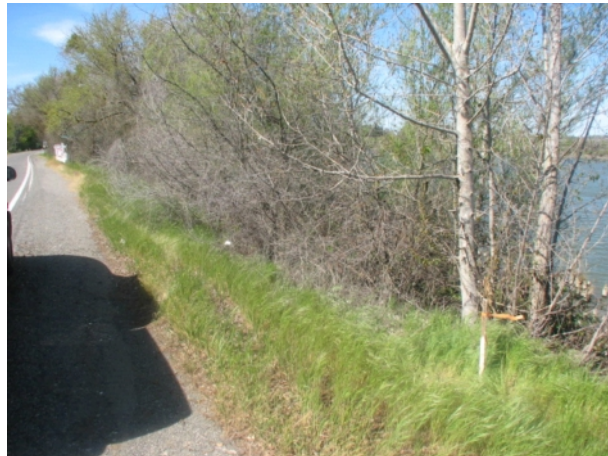
Levee Mile Report Line	26
Start Levee Mile	1.51
End Levee Mile	1.88
Location	Land Side
Category	Earthen Levee
Item	Trim / Thin Trees

Side view of dense trees along waterside slope.

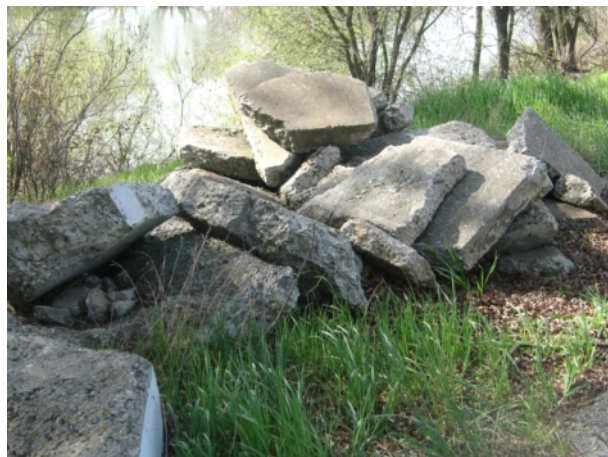
Levee Mile Report Line	30
Start Levee Mile	1.97
End Levee Mile	1.97
Location	Water Side
Category	Earthen Levee
Item	Encroachments

30	1.97	1.97	Earthen Levee	Encroachments	WS	M	Material Inspector Comments: Concrete rubble should be removed or broken up and spread out at waterward toe.	38.354888 ° -121.572540 °	38.354888 ° -121.572540 °	22 Y
31	2.06	2.06	Earthen Levee	Encroachments	WS	M	Material	38.355531 ° -121.571374 °	38.355531 ° -121.571374 °	80
32	2.20	2.22	Earthen Levee	Trim / Thin Trees	LS	M	Trim and thin trees to allow visibility of the ground and room to flood fight.	38.355402 ° -121.568893 °	38.355282 ° -121.568547 °	24
33	2.33	2.35	Earthen Levee	Trim / Thin Trees	WS	M	Trim trees to at least five feet above ground level.	38.354474 ° -121.566701 °	38.354555 ° -121.566191 °	40
34	2.41	2.53	Earthen Levee	Trim / Thin Trees	WS	M	Trim trees to at least five feet above ground level.	38.354916 ° -121.565167 °	38.355982 ° -121.563561 °	42
35	2.65	2.70	Earthen Levee	Trim / Thin Trees	LS	M	Trim and thin trees to allow visibility of the ground and room to flood fight.	38.357371 ° -121.562500 °	38.358132 ° -121.562347 °	82

Concrete rubble on waterside sholder at LM 1.97

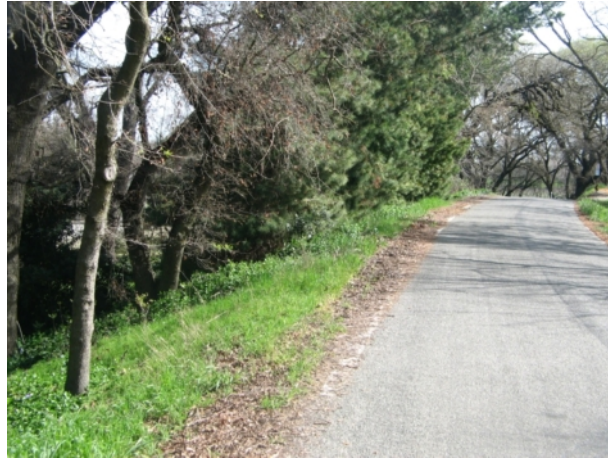
richard_f_20100921_288.jpg

Looking downstream of landscaping blocking view of landside slope from LM 3.19 to 3.24

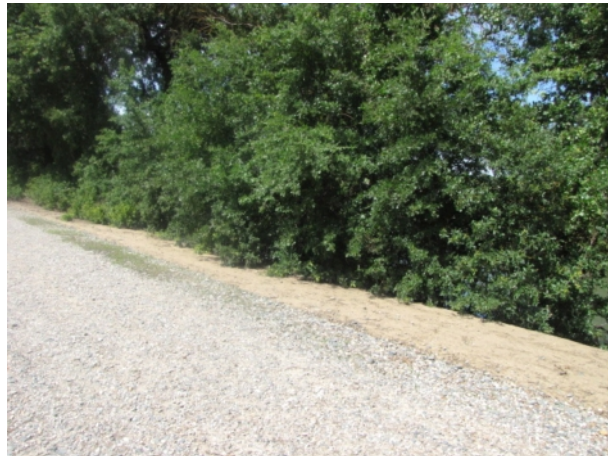
Levee Mile Report Line	52
Start Levee Mile	4.05
End Levee Mile	4.14
Location	Water Side
Category	Earthen Levee
Item	Trim / Thin Trees

Looking northeast at overgrown trees on waterside slope.

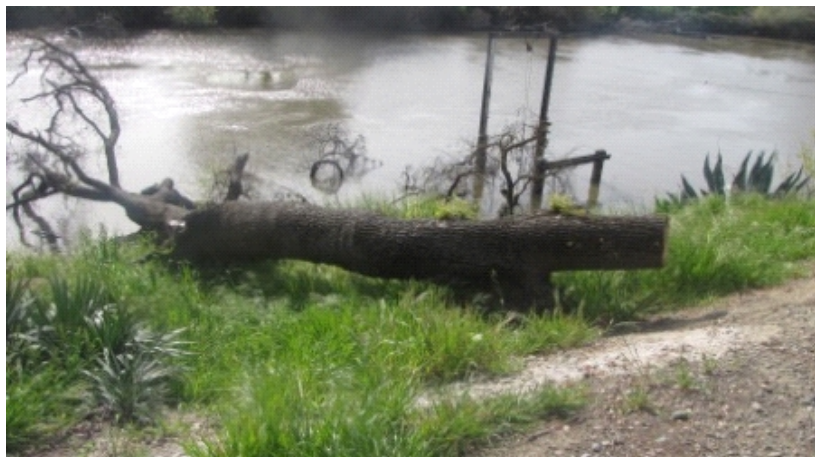
Levee Mile Report Line	54
Start Levee Mile	4.37
End Levee Mile	4.37
Location	Water Side
Category	Earthen Levee
Item	Encroachments

Looking south at down tree on waterside slope.

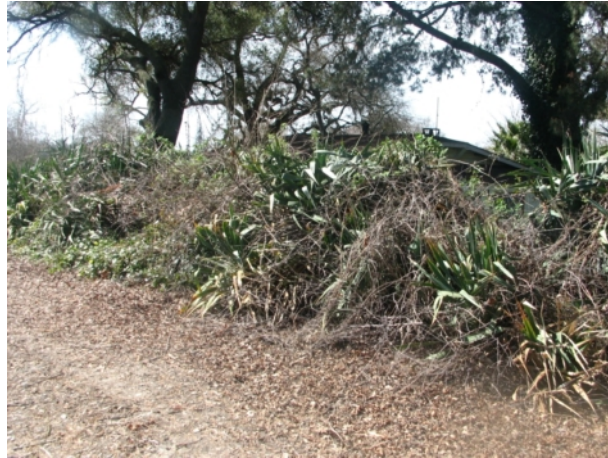
richard_f_20100921_292.jpg

Overgrown landscaping on landside slope blocking view of slope from LM 4.38 to 4.41

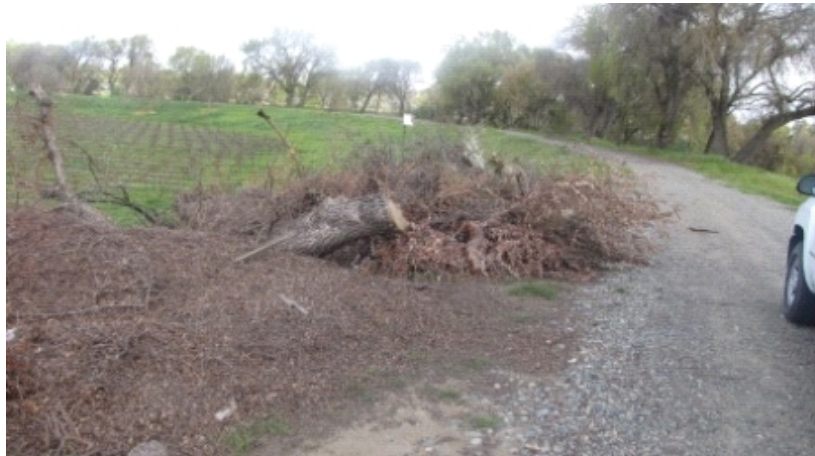
Levee Mile Report Line	71
Start Levee Mile	5.16
End Levee Mile	5.16
Location	Land Side
Category	Earthen Levee
Item	Encroachments

Looking northeast at prunings on landside shoulder and slope.

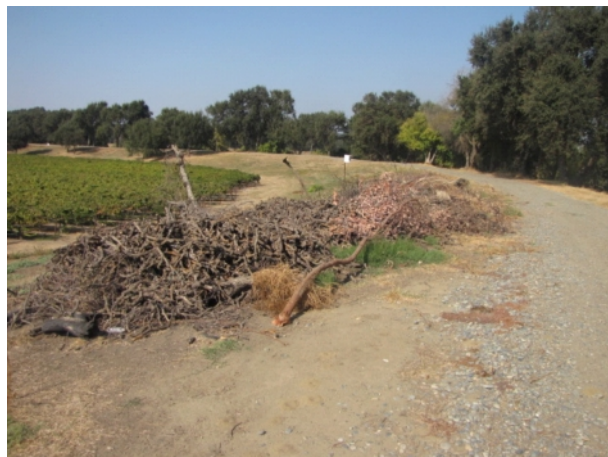
Levee Mile Report Line	71
Start Levee Mile	5.16
End Levee Mile	5.16
Location	Land Side
Category	Earthen Levee
Item	Encroachments

Looking northwest at pruning pile on landside slope.

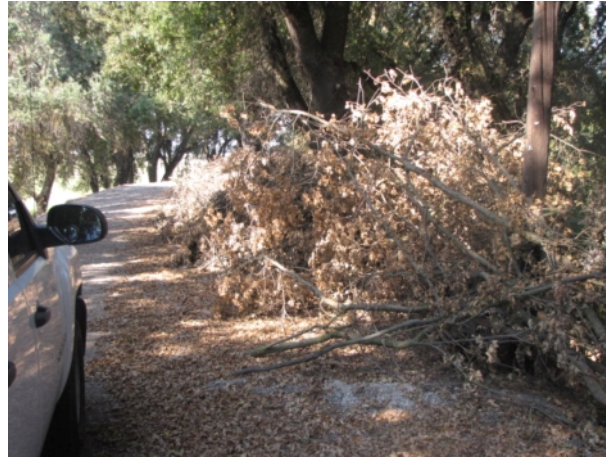
richard_f_20101021_347.jpg

Looking north at pruning piles on landside shoulder.

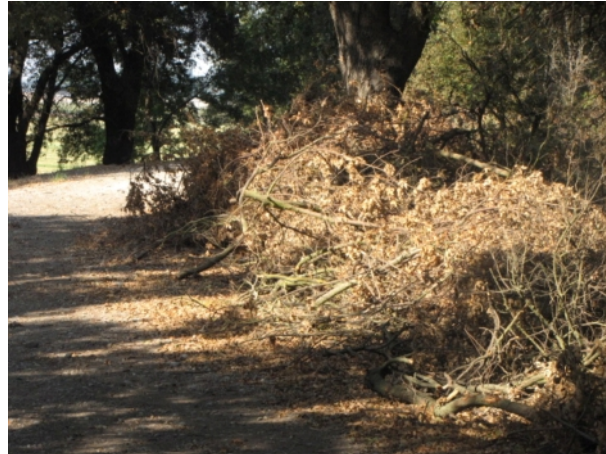
Levee Mile Report Line	83
Start Levee Mile	6.23
End Levee Mile	6.34
Location	Water Side
Category	Earthen Levee
Item	Encroachments

Looking northeast at pruning piles on landside shoulder.

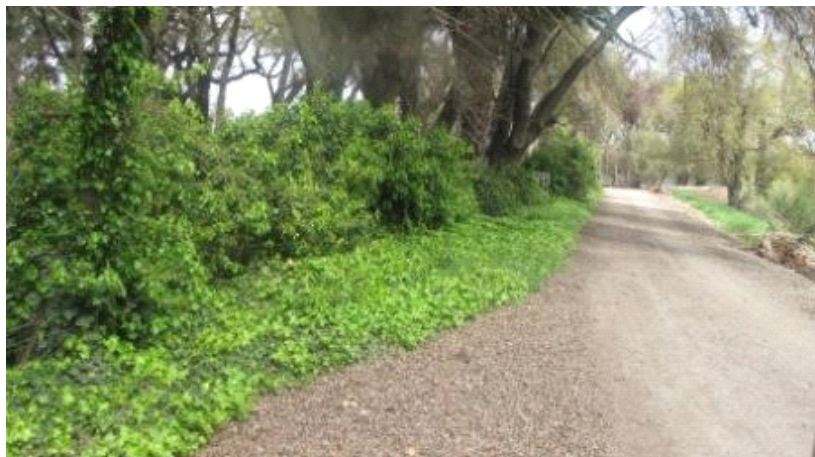
Levee Mile Report Line	88
Start Levee Mile	6.78
End Levee Mile	6.81
Location	Land Side
Category	Earthen Levee
Item	Encroachments

Looking north at overgrown landscape on landside slope and toe.

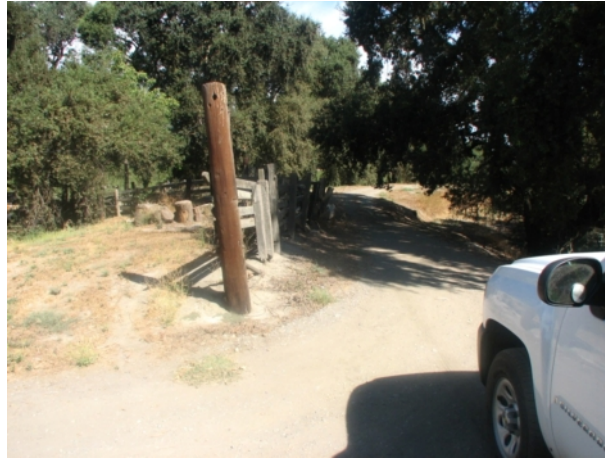
richard_f_20100921_300.jpg

Fence and Firewood at landside shoulder.

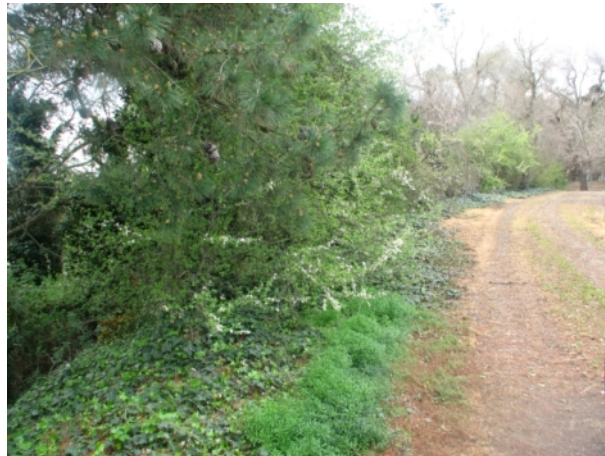
Levee Mile Report Line	90
Start Levee Mile	7.65
End Levee Mile	7.69
Location	Land Side
Category	Earthen Levee
Item	Encroachments

Landscaping on landside slope blocking view of slope from LM 7.65 to 7.72

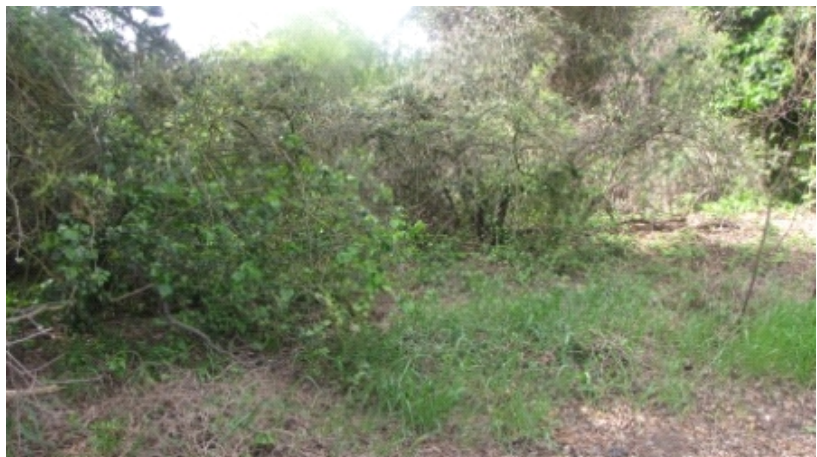
Levee Mile Report Line	90
Start Levee Mile	7.65
End Levee Mile	7.69
Location	Land Side
Category	Earthen Levee
Item	Encroachments

Looking east at overgrown landscape on landside slope.

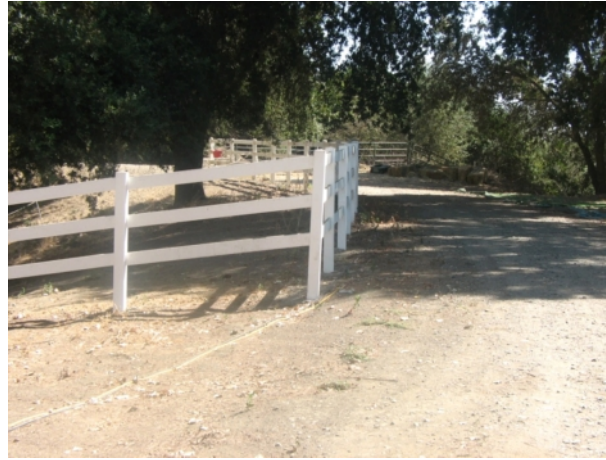
richard_f_20100921_303.jpg

New installed unauthorized fence at landside slope and shoulder.

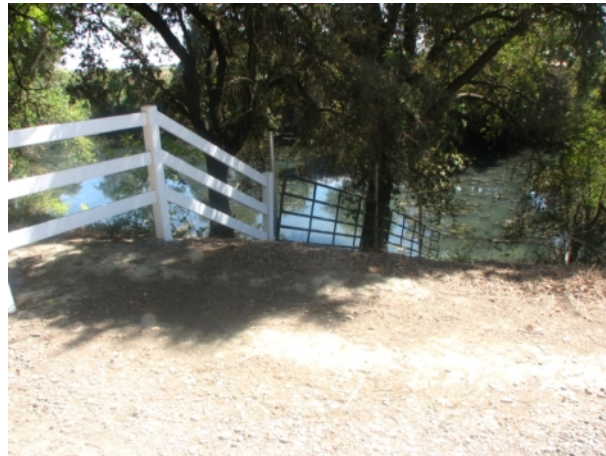
Levee Mile Report Line	102
Start Levee Mile	8.74
End Levee Mile	8.74
Location	Crown
Category	Earthen Levee
Item	Encroachments

New unauthorized fence that extend from landside toe to waterside toe.

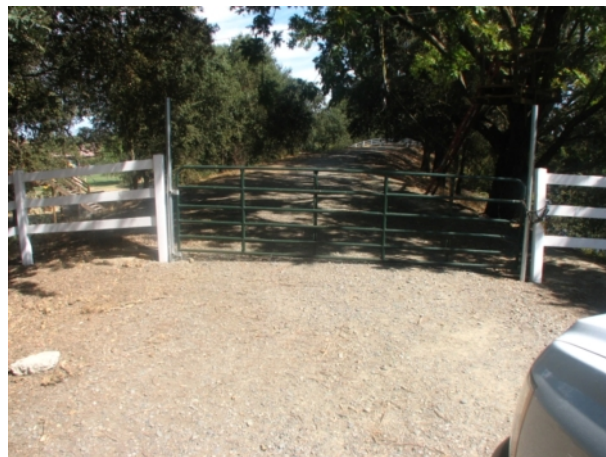
Levee Mile Report Line	102
Start Levee Mile	8.74
End Levee Mile	8.74
Location	Crown
Category	Earthen Levee
Item	Encroachments

View of fence & gate across levee crown, landside & waterside slope.
